# Lift installations – **ESV** identifies 19 areas of concern.

By **ESV Compliance Officer, Michael Bull**

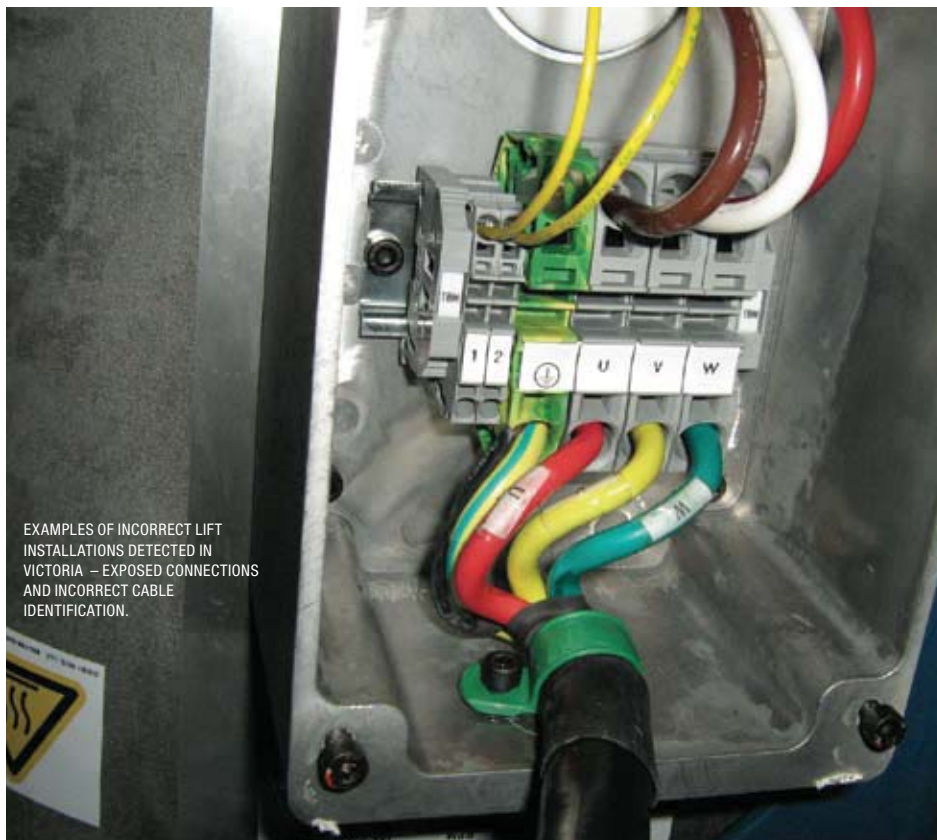
EXAMPLES OF INCORRECT LIFT INSTALLATIONS DETECTED IN VICTORIA – EXPOSED CONNECTIONS AND INCORRECT CABLE IDENTIFICATION.
