# Lift installations – **ESV** identifies 19 areas of concern.

By **ESV Compliance Officer, Michael Bull**

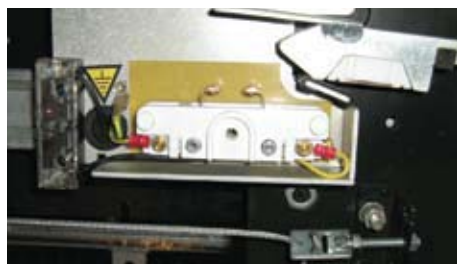
14. Electrical equipment was not installed to avoid harmful influence between circuits operating at different voltages.
15. Isolation devices were not clearly marked to identify the circuits they isolate.

16. Devices for switching off for mechanical maintenance were not placed and marked and convenient for their intended use.
17. Verification was not available to ensure circuit arrangements meets requirements of voltage drop and operation of protective devices.
18. Cables were installed that were not identified by the colours given in AS/NZS 3000:2000, Table 3.5.
19. Electrical workers are operating in different states and are not attaining the relevant state licence and at times some of the workers are not licensed at all.
